FOR NPS USE ONLY ENTRY NUMBER DATE (Type all entries - complete applicable sections) 1. NAME COMMON: Smithsonian Institution Building AND/OR HISTORIC: Smithsonian Institution Building 2. LOCATION STREET AND NUMBER: 1000 Jefferson Drive, S.W. CITY OR TOWN: Washington STATE COUNTY: CODE CODE District of Columbia 3. CLASSIFICATION CATEGORY **ACCESSIBLE** OWNERSHIP STATUS (Check One) TO THE PUBLIC Public District Public Acquisition: X Building X Occupied Restricted ☐ Site Private In Pracess ☐ Structure Unoccupied ☑ Unrestricted Both Being Considered Object Preservation wark ☐ No in progress PRESENT USE (Check One or More as Appropriate) Agricultural Pork X Government ☐ Transportation Comments Commercial Industrial Private Residence Other (Specify) Military X Educational Religious X Museum Entertainment Scientific OWNER OF PROPERTY Smithsonian Institution STREET AND NUMBER: Jefferson Drive, S.W. CITY OR TOWN: STATE: CODE Washington District of Columbia 5. LOCATION OF LEGAL DESCRIPTION COURTHOUSE, REGISTRY OF DEEDS, ETC: Recorder of Deeds STREET AND NUMBER: 6th and D Streets, N.W. CITY OR TOWN: STATE CODE District of Columbia Washington 6. REPRESENTATION IN EXISTING SURVEYS TITLE OF SURV

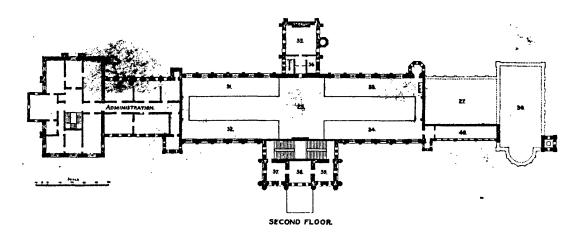
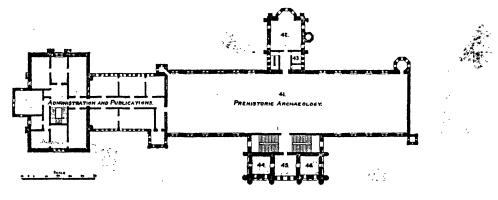
Second and Third Floor Plan ca. 1900

. PLAN OF SECOND AND THIRD FLOORS, SMITHSONIAN INSTITUTION BUILDING.
